EnduroSharp™ Nonmetallic (Torlon®) Aircraft Maintenance Tools

Paul K. Childers^{1,2}, Brett A. Bolan¹, and James J. Mazza¹

Air Force Research Laboratory,

¹Materials and Manufacturing Directorate

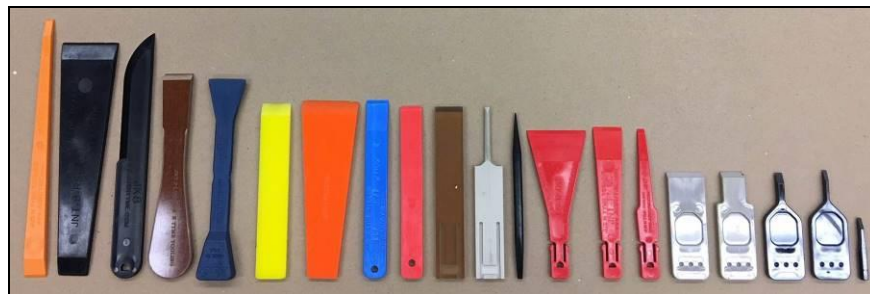
The approach adopted to develop enhanced nonmetallic material removal tools began with identifying the areas on aerospace vehicles requiring material removal and the types of materials that must be removed. In addition, ineffective nonmetallic material removal tools currently used were identified (Figure 1) and their deficiencies were studied to understand improvements required for new tools.

Figure 1. Ineffective Nonmetallic Material Removal Tools

After examining the available nonmetallic material removal tools (Figure 1) and identifying their deficiencies, as well as studying the attributes of metallic tools that allowed successful removal of materials, five configurations of prototype TSBs were designed, as shown in Figure 37.

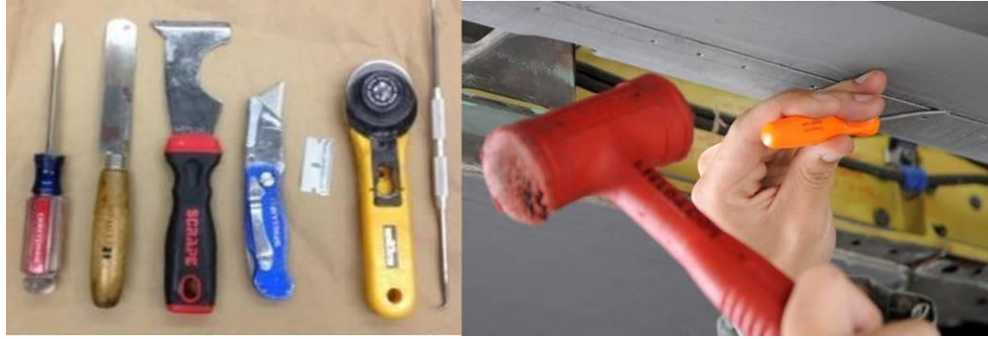
Furthermore, unauthorized metallic tools and methods (Figure 2) were also evaluated to determine the attributes that allow them to effectively remove identified materials.

Figure 2. Typical Unauthorized Tools and Methods

The typical gap filler remover is a narrow-ended nonmetallic tool, similar to a scraper blade (Figure 62). The tool is sharpened at the tip, which is its only cutting surface. This type of design requires the tool to be plunged completely through the gap filler to the surface of the structure at the bottom of the gap (no depth control). The tool is then pushed through the gap, shearing the material at the interface between the gap filler and the underlying structure (bottom of the gap). Due to the lack of cutting surfaces on the sides of the tool, gap filler adhered to the sides of the gap must be ripped from those surfaces via brute force. In some instances, to ease the removal process, aircraft maintainers use a traditional metal razor blade to separate gap filler from the sides of the gap, potentially damaging the structure, prior to using nonmetallic gap filler removal tools. Also, due to the lack of robust and effective gap filler removal using the existing scraper-like tools, maintainers often employ unapproved metallic tools (Figure 2).

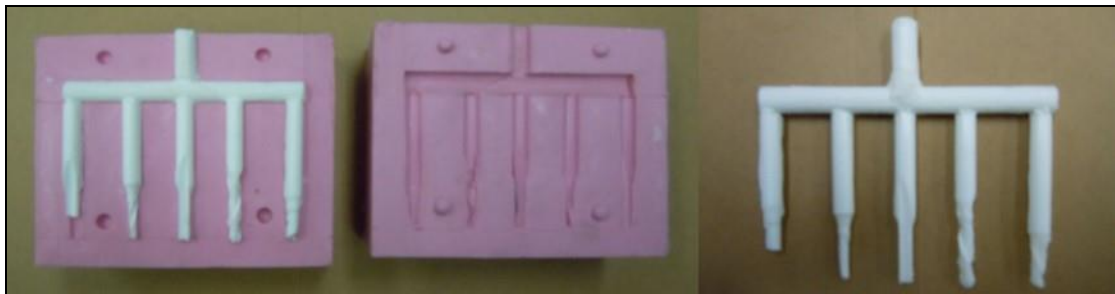
Once GFR-Bit configurations were identified for evaluation, a prototype mold was fabricated of the metallic bit using modeling clay and a Mold Max[®] series silicone rubber from Smooth-On, Inc. The GRF-bits were cast by pouring Smooth-On TASK[®] 8 heat-resistant polyurethane resin into the silicone rubber mold cavity. The prototype mold and GRF-bits are shown in Figure 5.

Figure 5. Prototype Mold and Bits

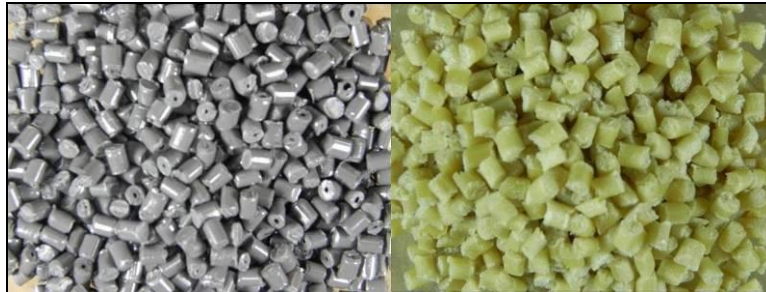
Unfilled Ultem® 1000 (polyetherimide resin) and Ultem 2300 (30 percent glass fiber reinforced) were selected to fabricate the next versions of GFR-Bits. The Ultem materials are produced in pellet form (Figure 7) and cannot be poured into a mold as was done with the TASK 8 heat-resistant polyurethane resin.

Figure 7. Ultem Pellets

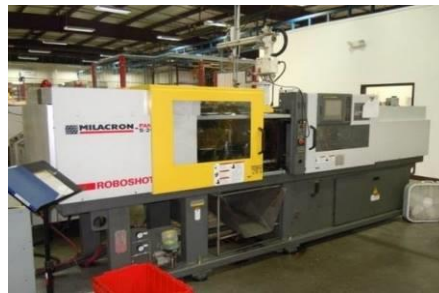
The Ultem materials had to be processed using injection molding equipment (Figure 8) due to the materials' inherently high-temperature melting points and viscosities.

Figure 8. Injection Molding Equipment

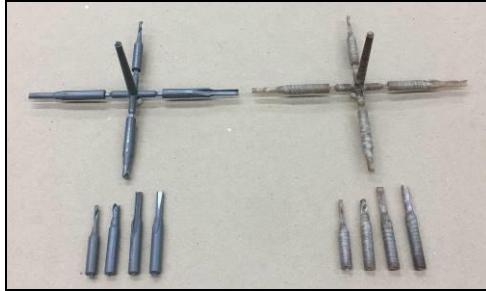
Estee Mold and Die (Dayton OH) manufactured a prototype injection mold tool and Priority Custom Molding, Inc. (Dayton OH) produced a limited production run of each configuration GFR-Bit with the two materials. Figure 10 shows the four different configurations of GFR-Bits after removal from the mold and after separation from the spurs.

Figure 10. Ultem 1000 and Ultem 2300 GFR-Bits

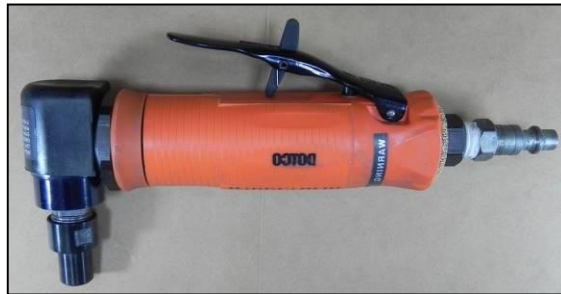
The GFR-Bits were mounted on a 20,000 revolutions per minute (rpm) Dotco[®] 90-degree grinder (model 12L1281-36), as shown in Figure 11, connected to a 620 kPa (90 psi) compressed air source.

Figure 11. Dotco (20,000 rpm) 90-degree Grinder

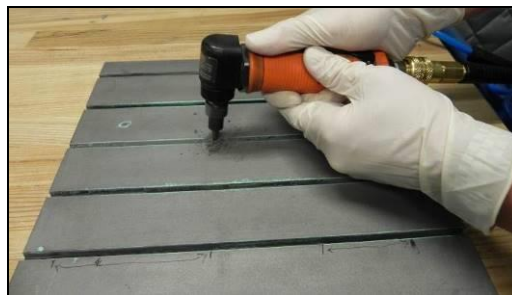
Both Ultem 1000 and Ultem 2300 GFR-Bits successfully removed small sections of flexibilized epoxy gap filler from test panel gaps before failing (Figure 12).

Figure 12. Ultem 1000 and 2300 GFR-Bit Demonstration

Although the demonstration was successful in illustrating Ultem GFR-Bits could remove gap filler without damaging the test panels and do so much more efficiently than GFR-Bits manufactured from Smooth-On TASK 8 polyurethane resin, Ultem GFR-Bits still lacked the durability necessary to remove more than about 15 cm (6 in) of material before failing. The target gap filler removal length for this project was over 91 linear centimeters (36 in) to be removed by one bit.

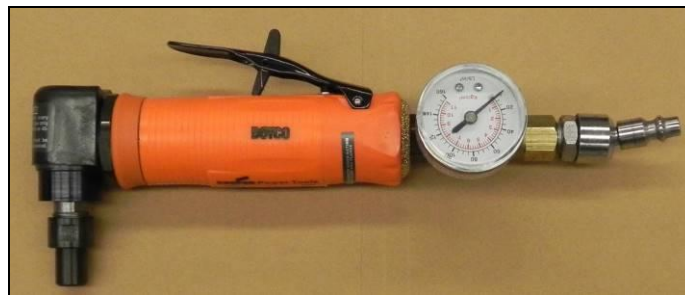
The GFR-Bits were mounted on the same 20,000 rpm grinder used previously, which was fitted with a inline air regulator, as shown in Figure 13, to enable line pressure adjustment and allow for the evaluation of the effects of varying grinder rpm.

Figure 13. Dotco (20,000 rpm) 90-degree Grinder with Regulator

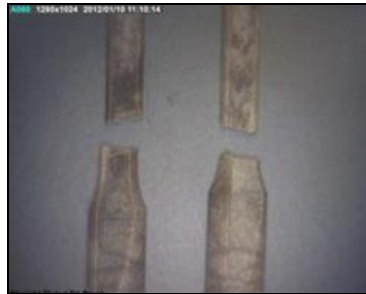
The evaluation showed all three remaining GFR-Bit configurations under consideration could remove the gap filler. However, using 69 kPa (10 psi) line pressure, the straight single flute and straight double flute GFR-Bits required extreme care when inserting them into a gap. These GFR-Bits would chatter and break (Figure 15) due to their asymmetrical cutting surfaces operating at slow speed.

Figure 15. Typical Failure of Straight Single and Double Flute GFR-Bits

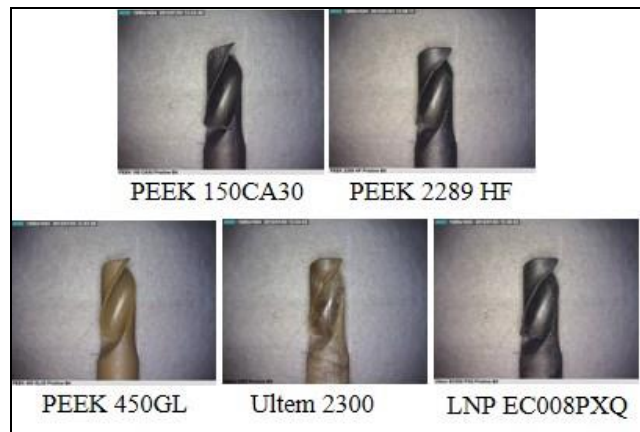
Spiral single flute GFR-Bits manufactured with these selected materials, as well as similar bits fabricated from LNP Thermocomp Compound EC008PXQ, were then used to remove two types of flexibilized epoxy gap filler, identified as “old” and “new,” from a 30.48 cm (12.0 in) gap length. The bits were photographed before and after removal of old gap filler, as shown in Figure 19 and Figure 20, respectively. The mass of each GFR-Bit was obtained before and after gap filler removal to determine mass loss during the removal process.

Figure 19. Pristine GFR-Bits

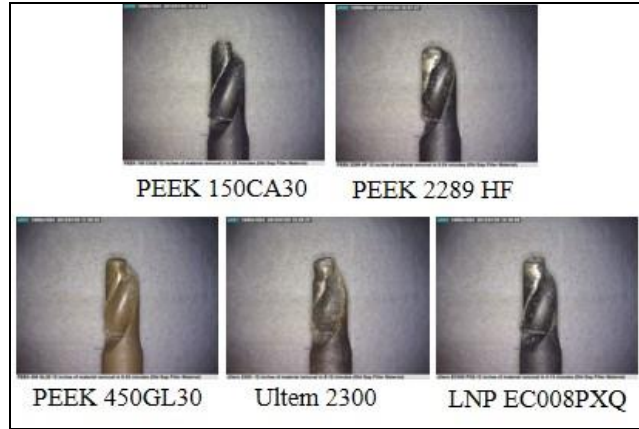
Figure 20. GFR-Bits after Removing Old Gap Filler

In addition, the time to remove 30.48 cm (12.0 in) of old gap filler was recorded using a stopwatch; Table 1 provides details for the GFR-Bit removal evaluations on old gap filler.

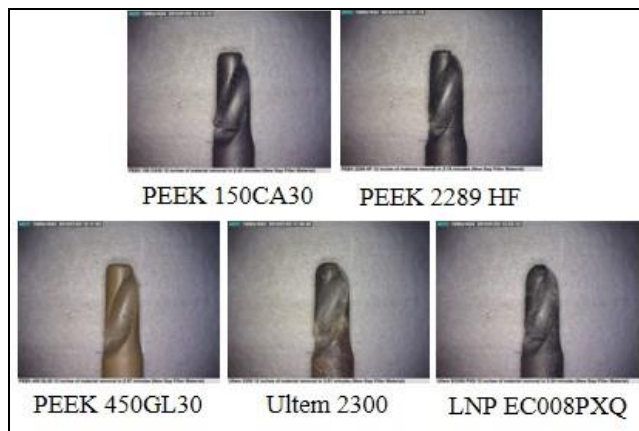
Images of the GFR-Bits after removing 30.48 cm (12.0 in) of new gap filler are provided in Figure 21.

Figure 21. GFR-Bits after Removing New Gap Filler

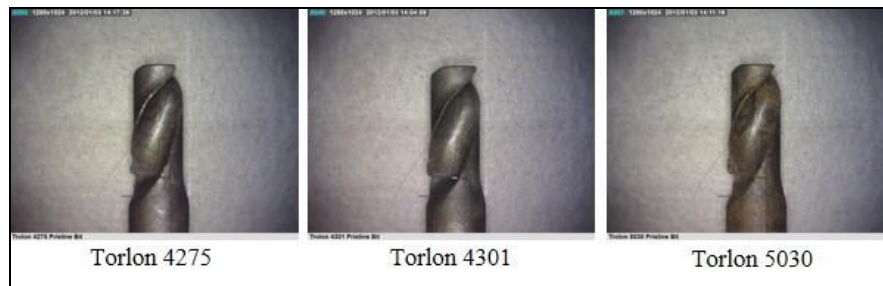
The three Torlon candidates were evaluated in the same manner as the previous materials. Images of the bits prior to the removal trials are shown in Figure 22.

Figure 22. Pristine Torlon GRF-Bits

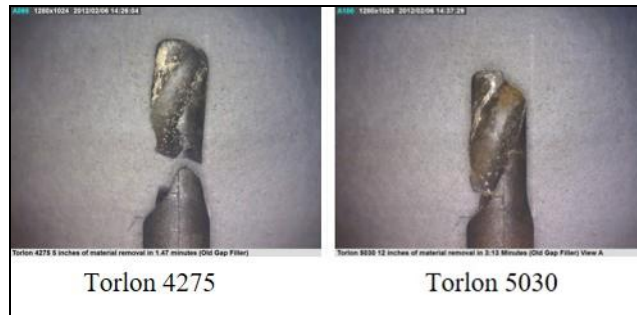
Images of the bits after attempting to remove 30.48 cm (12 in) of old and new gap filler are shown in Figure 23 and Figure 24, respectively. Additionally, the times required for each bit to remove the gap filler material are provided in Table 3 and Table 4. Torlon 4301 was not evaluated with old gap filler.

Figure 23. Torlon GFR-Bits after Removing Old Gap Filler

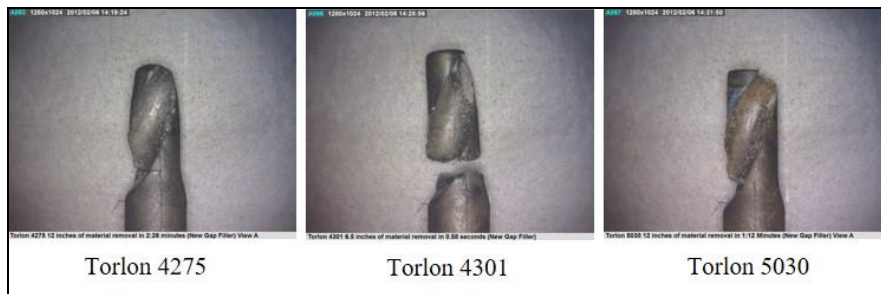
Figure 24. Torlon GFR-Bits after Removing New Gap Filler

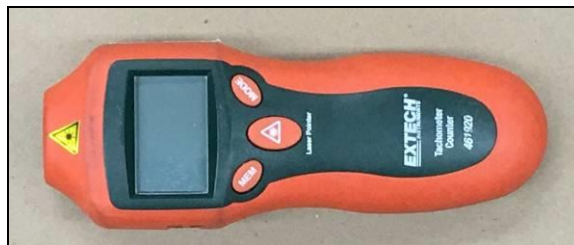
As noted previously, the supply compressed air pressure was lowered to reduce the speed of the 20,000 rpm grinder to prevent GFR-Bit damage (exceeding material service temperature); however, this degraded the efficiency of the 20,000 rpm grinder due to lost torque. To see if another tool would perform better (without too much loss of torque), a 12,000 rpm Dotco grinder (model 12L1280-36) with reduced line pressure was evaluated. To establish a line pressure for the 12,000 rpm grinder, the rpm generated with the 20,000 rpm grinder operated at 172 kPa (25 psi) was measured using an Extech model 461920 tachometer (Figure 25).

Figure 25. Extech Tachometer

It was determined the 20,000 rpm grinder operated at 172 kPa (25 psi) rotated between 5,900 and 6,700 rpm free spinning (no load applied). The 12,000 rpm grinder was connected to the same compressed air source and the line pressure was adjusted via an inline air regulator until the free spinning rpm reached a range between 6,000 and 7,000 rpm, which occurred at about 241-310 kPa (35-45 psi). Cursory tests using Torlon 5030 GFR-Bits were repeated to ensure the 12,000 rpm grinder with the air regulator set at 310 kPa (45 psi) produced results similar to those observed during earlier evaluations. Results showed material removal rates increased without the grinder bogging down, and less applied force was required to advance the GFR-Bit through the gap filler, so the 12,000 rpm Dotco with 241-310 kPa (35-45 psi) line pressure was adopted.

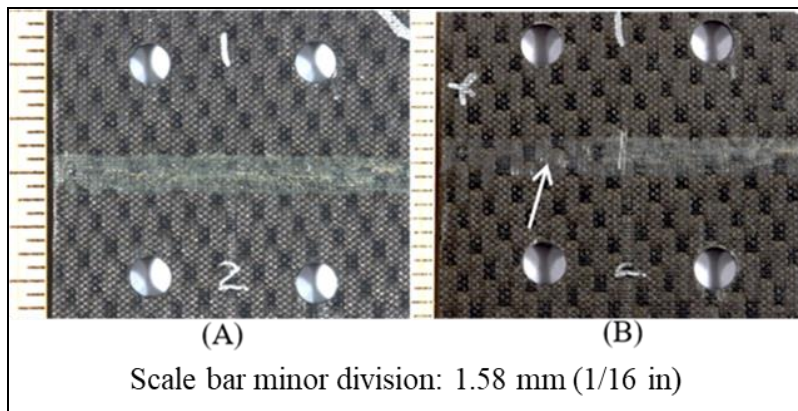
Figure 29. Epoxy Test Panel

The epoxy test panel base surface impingement area is shown in Figure 29 before cleaning (A) and after cleaning of one-half of the impinged area, as indicated by the arrow (B).

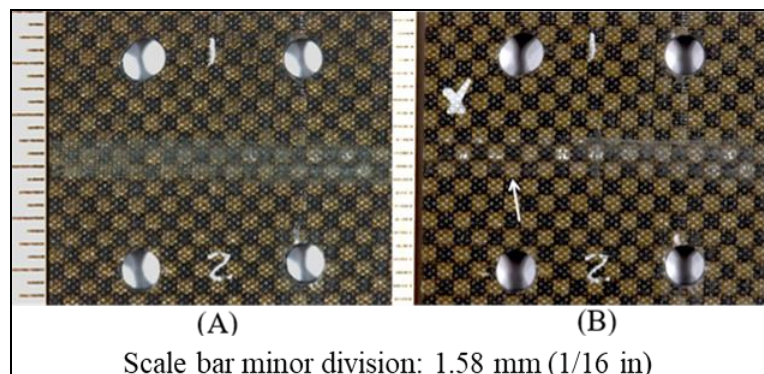
Figure 34. BMI Test Panel

The impinged test panel base, prior to cleaning (A) and after cleaning (B), is shown in Figure 34. GFR-Bit material can be seen on the impinged surface near the center of the images. Remnant Torlon was cleaned from one-half of the impinged area, as indicated by the arrow (B).

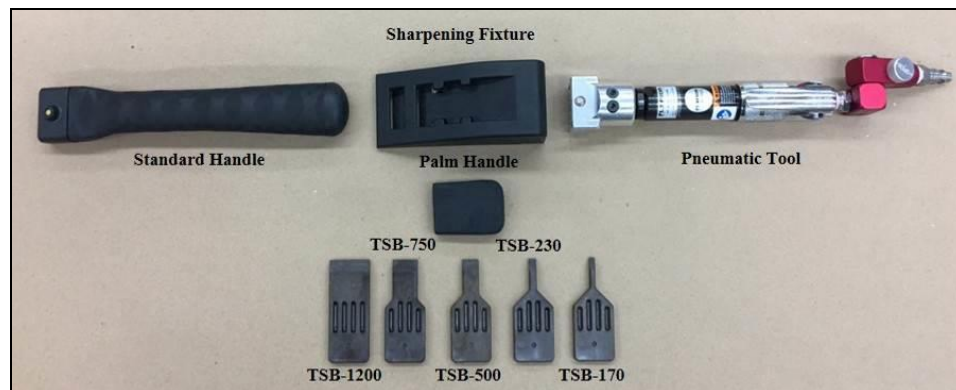
Figure 40. Commercially Available Injection Molded TSBs and Accessories

Accessories required to use TSBs and enhance their effectiveness were adapted or developed. These include handles, a pneumatic tool, and a fixture that ensures the 25°/25° asymmetrical 1/3-2/3 cutting tip is maintained during sharpening (Figure 40). The pneumatic tool is a modified gasket scraper fitted with a blade adapter designed to accommodate TSBs. Development work associated with the accessories is not discussed in this paper.

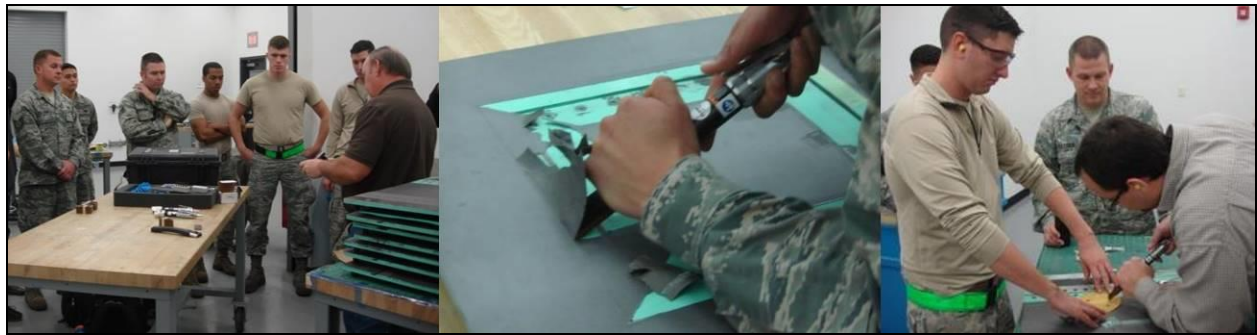
Figure 42. TSB Demonstration and Field Evaluation

Next, the TSBs were demonstrated at several repair depots and operational maintenance units (Figure 42) for additional feedback prior to manufacturing of injection molds and production of the injection molded TSB versions. As stated earlier, the machined TSB production cost is about \$70, whereas the injection molded TSB production cost is significantly less.

As with the TSBs, the next step was to demonstrate TBGs at several repair depots and operational maintenance units (Figure 42) for additional feedback prior to the manufacturing of molds and parts inserts for production of injection molded TGBs.

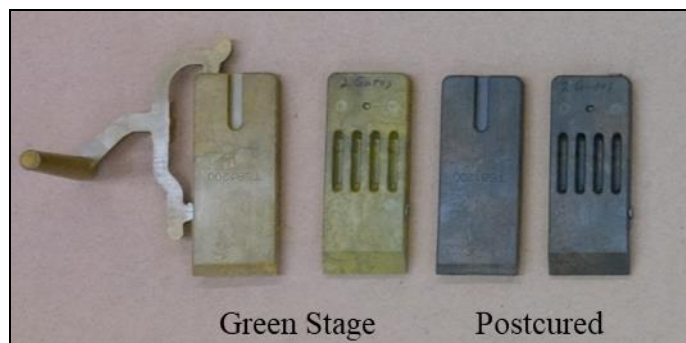
Figure 43. Injection Molded TSBs (TSB-1200)

For final article testing, injection mold bases and part inserts were manufactured, and the five final TSB configurations were produced, which included the following blade widths: 30.5 mm (1.2 in), 19 mm (0.75 in), 12.7 mm (0.5 in), 5.8 mm (0.23 in) and 4.3 mm (0.17 in). Results for the largest configuration (TSB-1200) are presented as a representative example (Figure 43). Torlon 5030 TSBs come out of the injection mold in a green state (not fully cured) and then receive a 21-day postcure at 260°C (500°F) to produce a final part. The postcure process darkens the material's color and increases TSB wear resistance and strength.

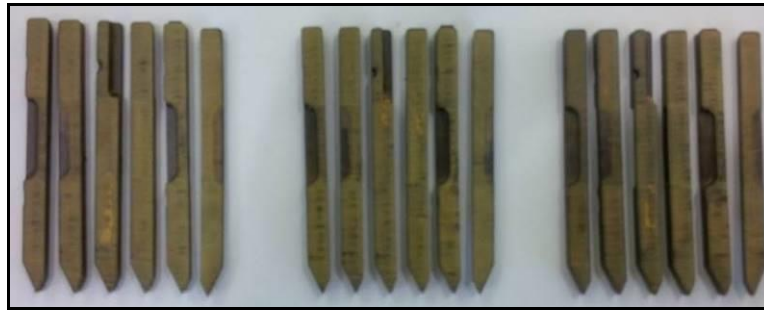
Figure 44. Sectioned Injection Molded TSBs

The green stage and postcured injection molded TSBs were evaluated for part thickness variation and porosity concentration. A sampling of the injection molded TSBs were cross-sectioned for evaluation (Figure 44). No anomalies were observed.

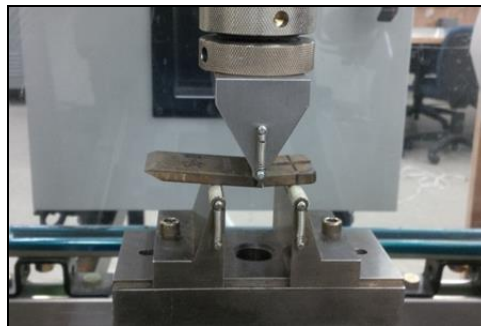
Figure 45. TSB Three-Point Bend Test Setup

To evaluate TSB-1200 bending strength, mechanical tests were performed using a three-point bending configuration with a 35.6 mm (1.4 in) span and a 3.2 mm (0.125 in) radius loading nose (Figure 45). The three-point bend test matrix and average peak loads obtained (minimum of five test specimens) are presented in Table 5.

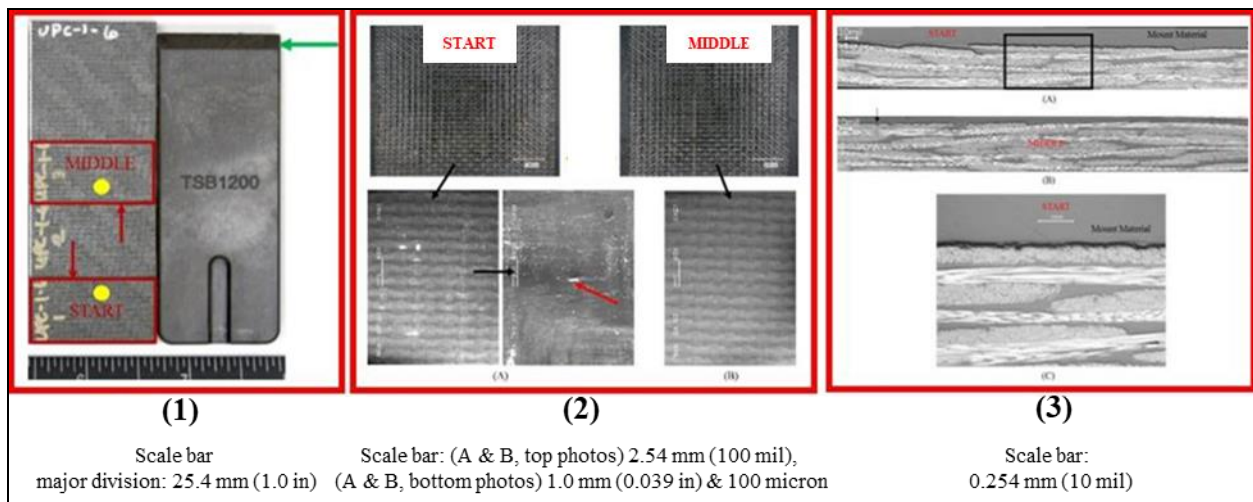
Figure 54. TSB-1200 (45°) Unprimed Test Panel Test Area

Photo documentation of the test area from specimen UPC-1-6 (see Table 6) is provided in Figure 54 and is divided into three sections similar to those described above for UPC-1-1. This test consisted of six passes of a TSB-1200 at a 45° angle to the panel surface. As was the case for specimen UPC-1-1, some fibers from the TSB were found on the test panel surface but no damage to the test panel was evident. Magnified views of the test area showed no exposed test panel fibers or subsurface cracks caused by TSB passes over the area.

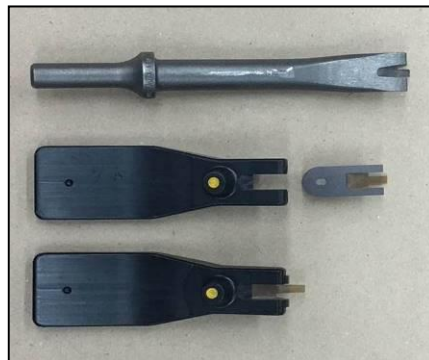
Figure 65. Sheet Metal Ripper with Prototype TGBs and Adapters

The TGB design was based on a commercially available metallic sheet metal ripper, which is shown in Figure 65 alongside prototype TGBs and adapters.

Prototype TGBs were machined from a 12.7 mm (0.50 in) thick extruded Torlon 5030 sheet, and the adapter was machined from 25.4 mm (1.0 in) thick unfilled DuPont™ Delrin® thermoplastic.

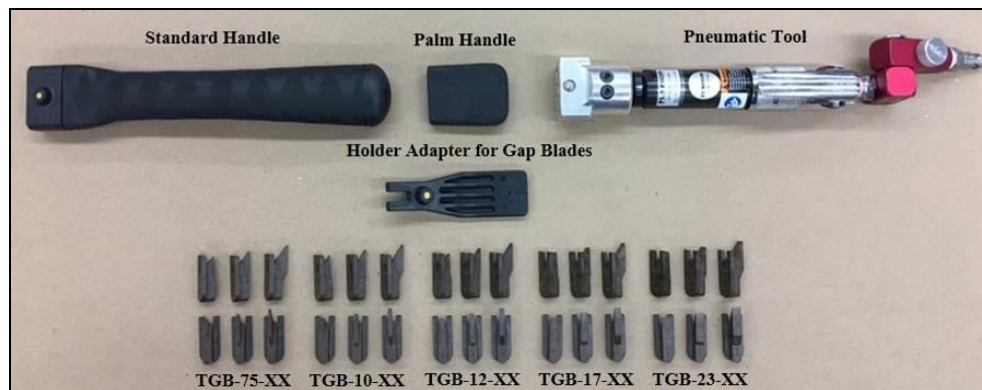
Figure 66. TGBs and Accessories

Commercialized (injection molded) TGBs and accessories are shown in Figure 66. The blades are available in five widths: 1.9 mm (0.075 in), 2.5 mm (0.10 in), 3.05 mm (0.12 in), 4.3 mm (0.17 in) and 5.8 mm (0.23 in). Each blade width is available in three cutting depths: 1.9 mm (0.075 in), 4.1 mm (0.16 in) and 6.35 mm (0.25 in). The multiple depths allow for incremental

removal of gap filler, starting with the shallowest-depth blade and followed by the other two depths, as needed. This technique eases removal and can reduce removal time even though multiple blades are used.

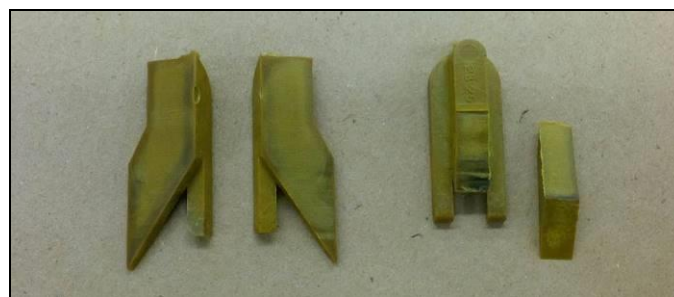
Figure 70. Sectioned Injection Molded TGBs (Green Stage)

The green stage and postcured injection molded TGBs were evaluated for part thickness variation and porosity concentration. A sampling of the injection molded TGBs were cross-sectioned for evaluation (Figure 70). No anomalies were observed.

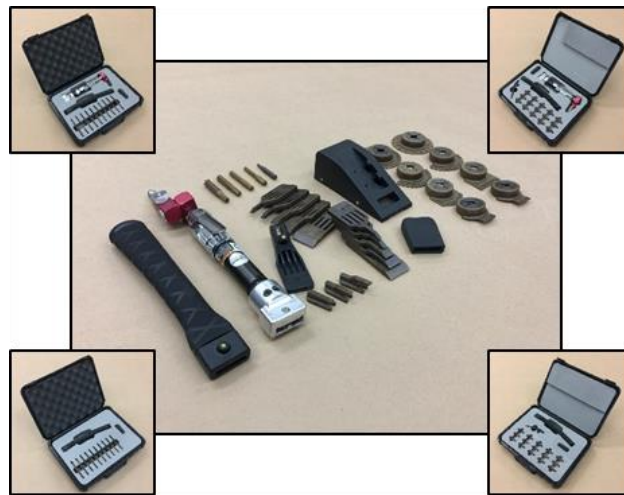
Figure 82. EnduroSharp™ Nonmetallic Material Removal Tools

The AFRL/UDRI-developed GFR-Bits, TSBs and TGBs are now commercially available from Performance Plastics, LTD (Cincinnati, OH) under the EnduroSharp trade name. The EnduroSharp removal tools have been evaluated and approved for applications on multiple aerostructures and have several industrial applications as well.
